Navajo Abandoned Uranium Mine

Site Screen Report

North Portal, Frank No. 1 Mine AUM Site

March 2010

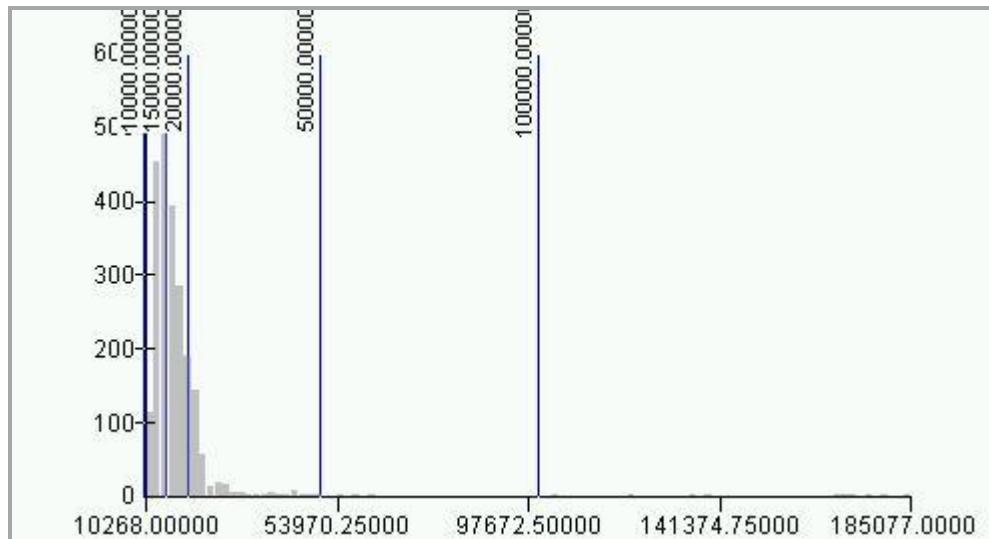
The following chart and statistics were generated by ESRI ArcGIS 9.3.1, and show the general distribution of the site gamma radiation measurements. The horizontal X axis represents the gamma radiation reading levels in cpm (lowest levels to the left). The vertical Y axis represents the frequency of each gamma radiation level.

Count:	2331
Minimum:	10268.00000
Maximum:	185077.00000
Sum:	44893687.00000
Mean:	19259.41098
Median:	15738.00000
Standard Deviation:	18269.64267

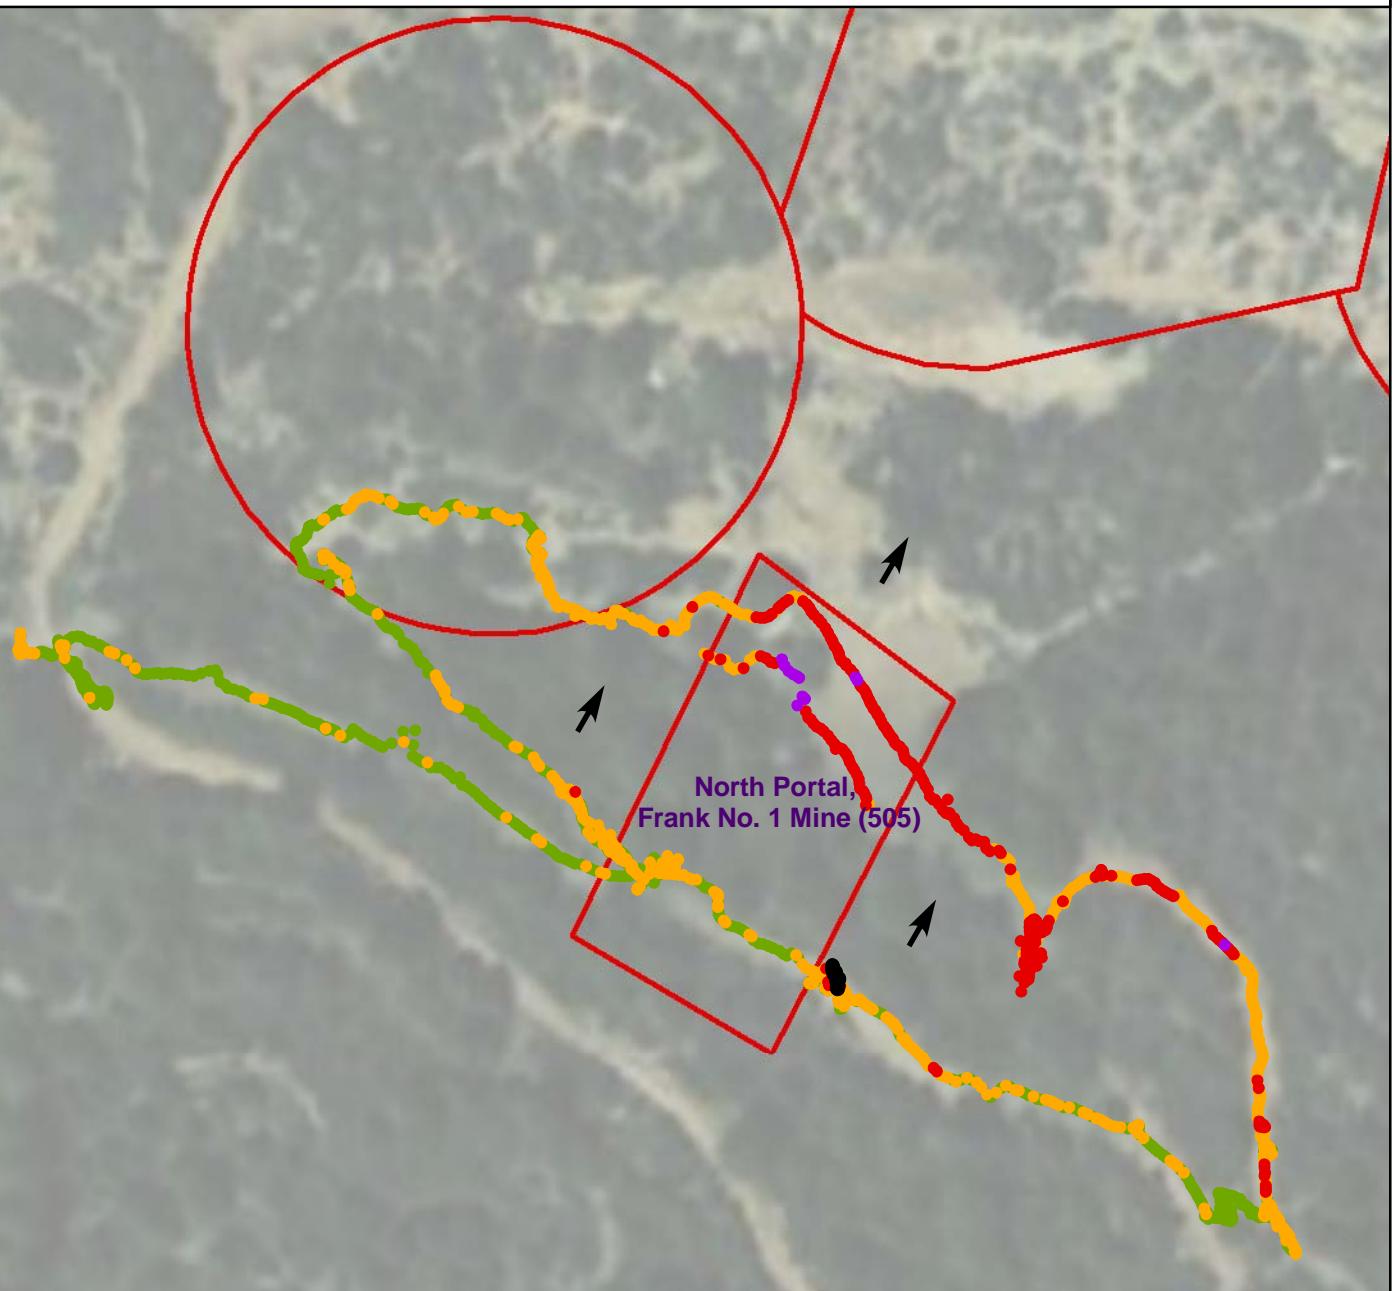
Figure 1 - Gamma Radiation Measurements, Above Two Times Background
North Portal, Frank No. 1 Mine (505)
Cove Chapter, Navajo Nation, Arizona

A total of 2,331 gamma radiation measurements were collected from the mine site, ranging from 10,268 cpm to 185,077 cpm. Measurements in the vicinity of the 'Cul-de -sac' area near center of site were found at levels of approximately 25,000 cpm, a rocky outcropping southeast of the site was found at levels of approximately 170,000 cpm. The measurements are represented in Figures 1 and 2.
